# **AmerenUE's Storm Outage Planning and Restoration Effort Following the Storms on July 19 and 21, 2006**

**Case No. EO-2007-0037**  
**Missouri Public Service Commission Staff**  
**November 17, 2006**

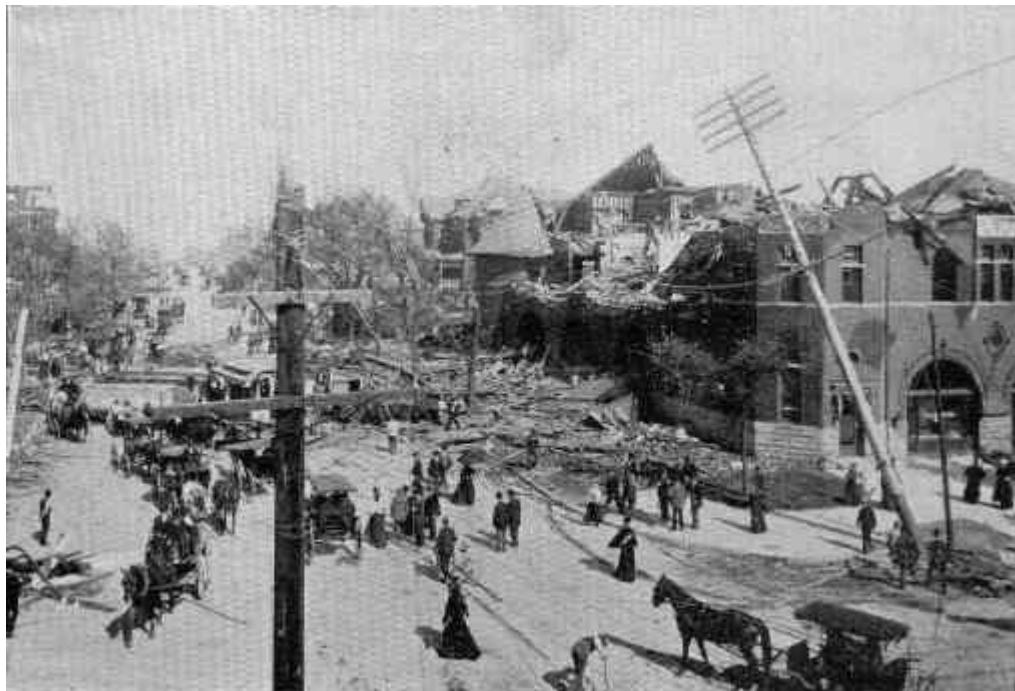
In a St. Louis Post-Dispatch article on August 13, 2006, referencing damage to Tower Grove Park, sources reported that “114 trees overturned, and 100 more may need to be cut down” and “The storm was the second worst to hit the park since it was founded in 1868. The only event more destructive was the Great Cyclone of 1896...”

Picture from this website link of damage in St. Louis:

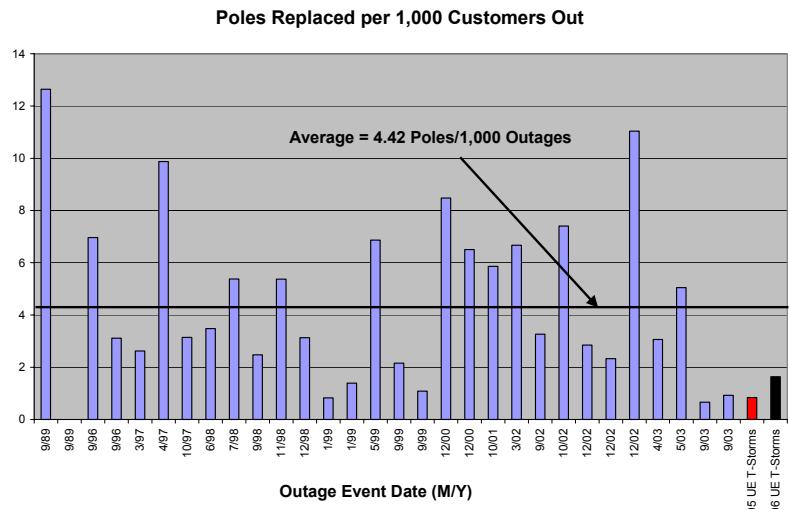
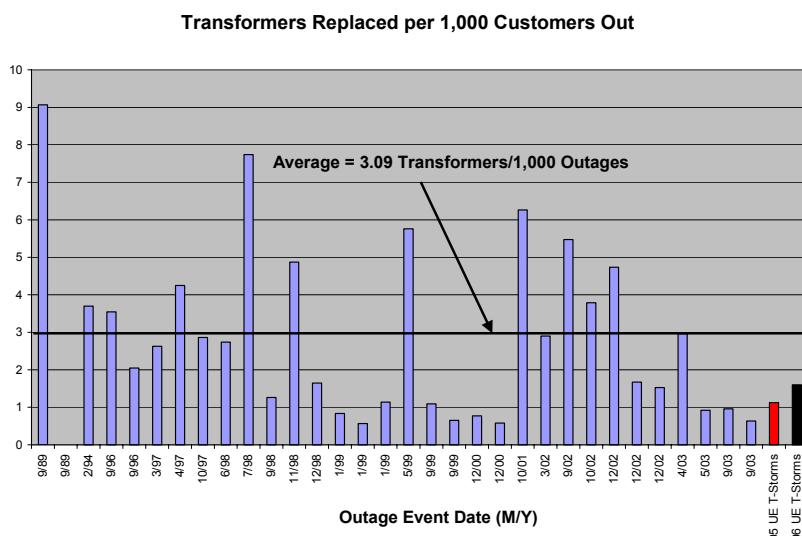
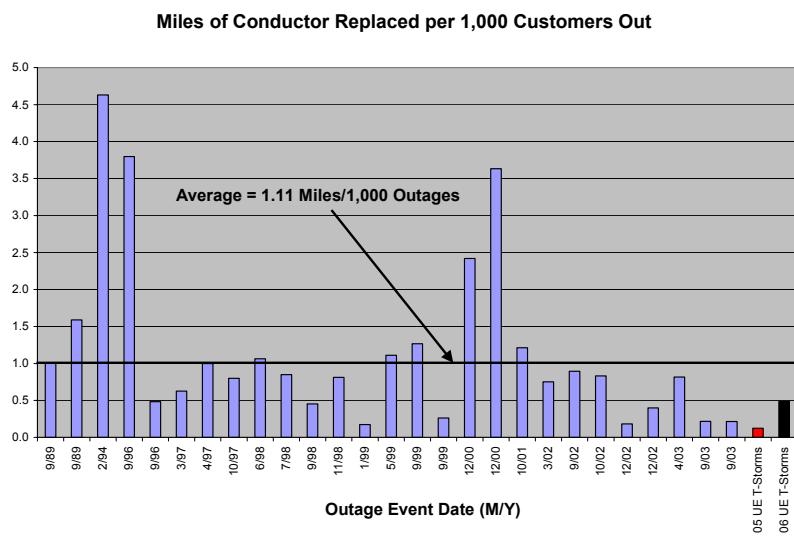
In response to concerns about poorly maintained infrastructure contributing to the extent of damage to AmerenUE's system, Staff looked at the number of broken poles, transformers and conductor miles that had to be replaced per 1,000 customers experiencing an outage. The following three graphs show that AmerenUE's system experienced a lower than average frequency of broken poles, damaged transformers and replaced conductors associated with this outage restoration effort.

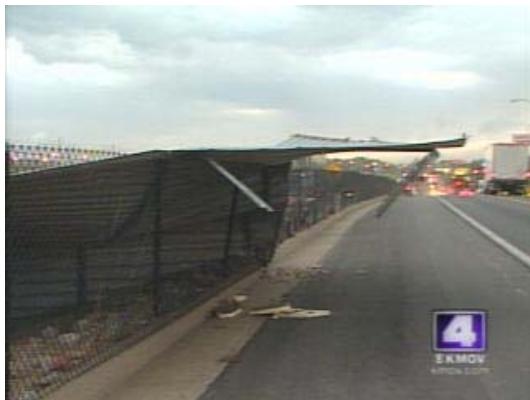
Part of Lambert Terminal Roof on I-70  
(Courtesy: Channel 4, St. Louis)

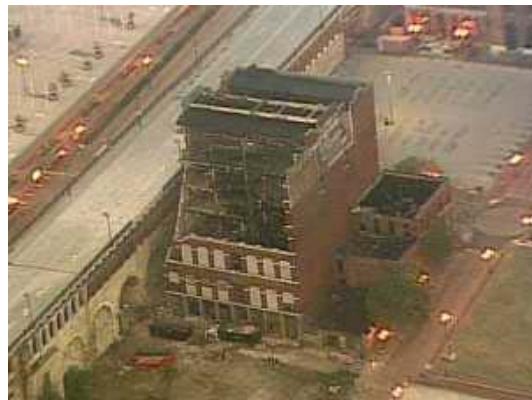
Switzer Bldg. in Laclede's Landing  
(Courtesy: Ameren)

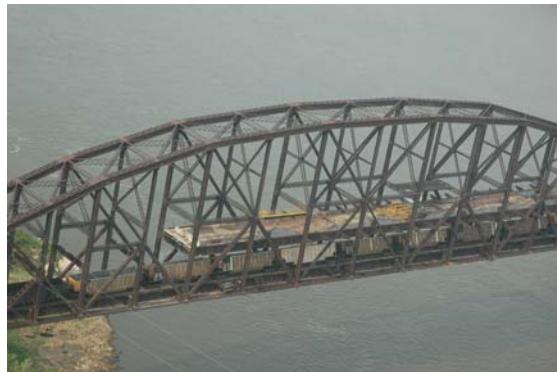
Tipped Rail Cars on Bridge  
(Courtesy: Ameren)

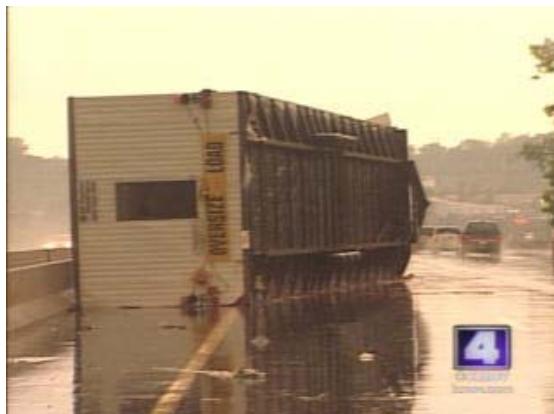
Manufactured Home on Highway  
(Courtesy: Channel 4, St. Louis)
