# **AmerenUE's Storm Outage Planning and Restoration Effort Following the Storms on July 19 and 21, 2006**

**Case No. EO-2007-0037**  
**Missouri Public Service Commission Staff**  
**November 17, 2006**

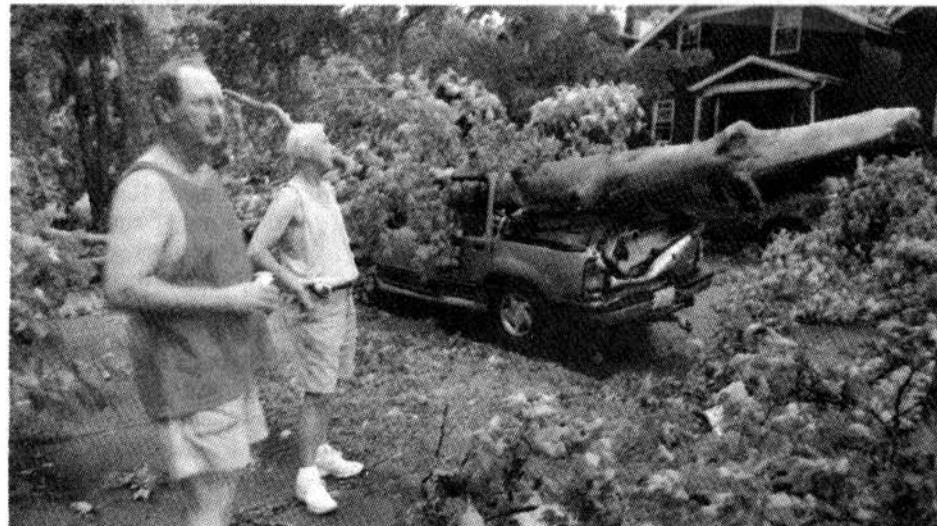
Neighbors Hugh Wheeler (left) and Terry Penberthy stand amid damage on Louisville Avenue in St. Louis' Dogtown neighborhood. Jerry Naunheim Jr. | Post-Dispatch

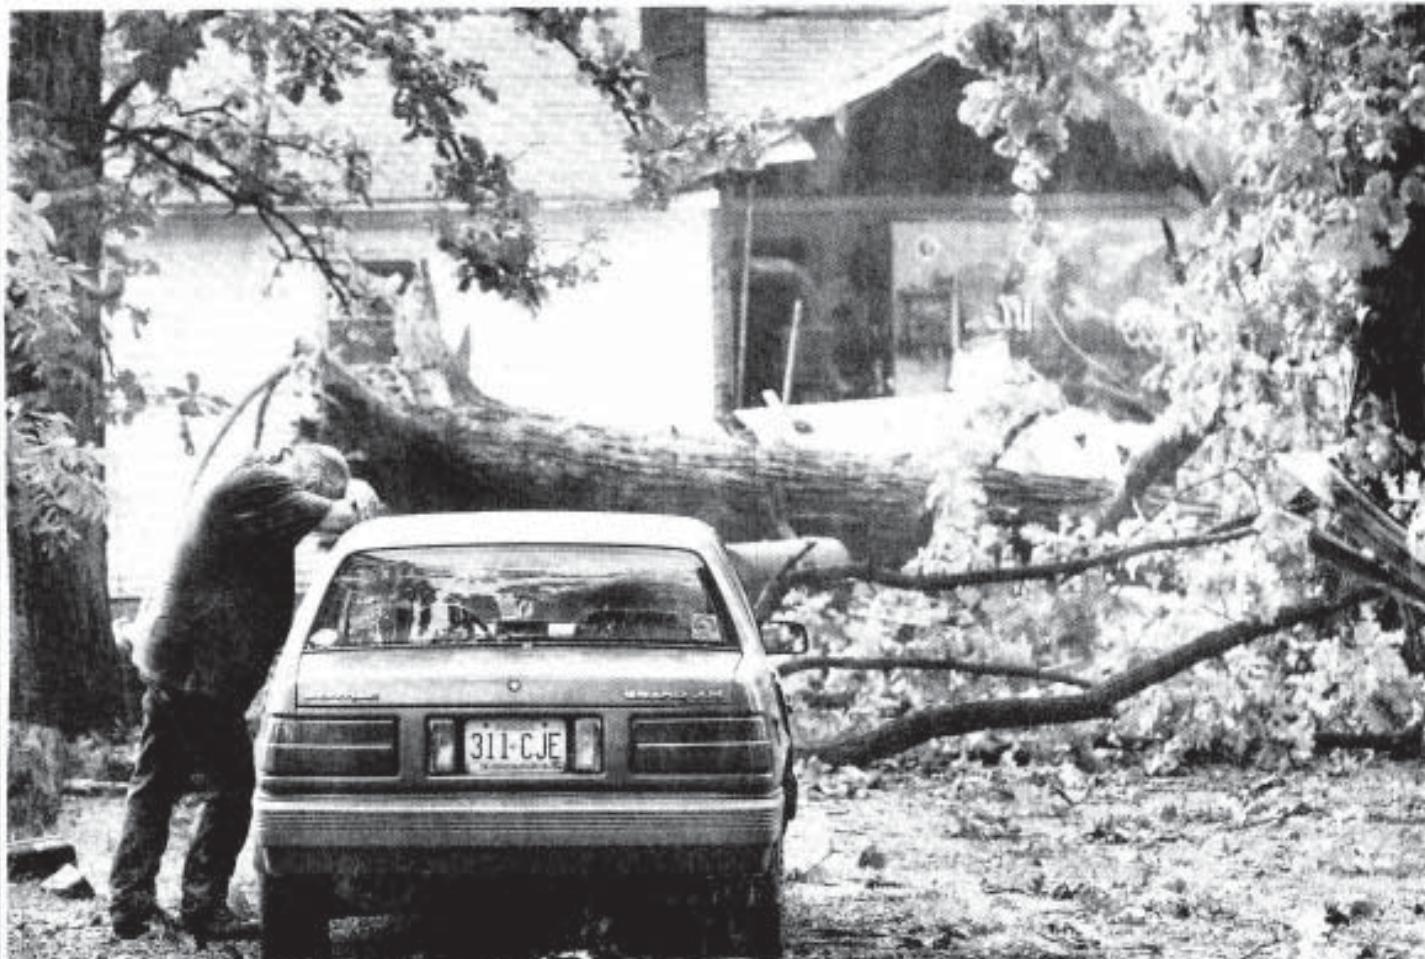
In Arnold on Thursday, Tom Harris waits for the arrival of the American Red Cross after trying to salvage belongings at his home on Fannie Drive. A large white oak tree ripped through his living room Wednesday night while he and his wife, Tana, were watching television weather reports with their family. When the roof collapsed, his son Levi, 5, was trapped and was freed when family members lifted the roof trusses. (Robert Cohen/St. Louis Post-Dispatch)

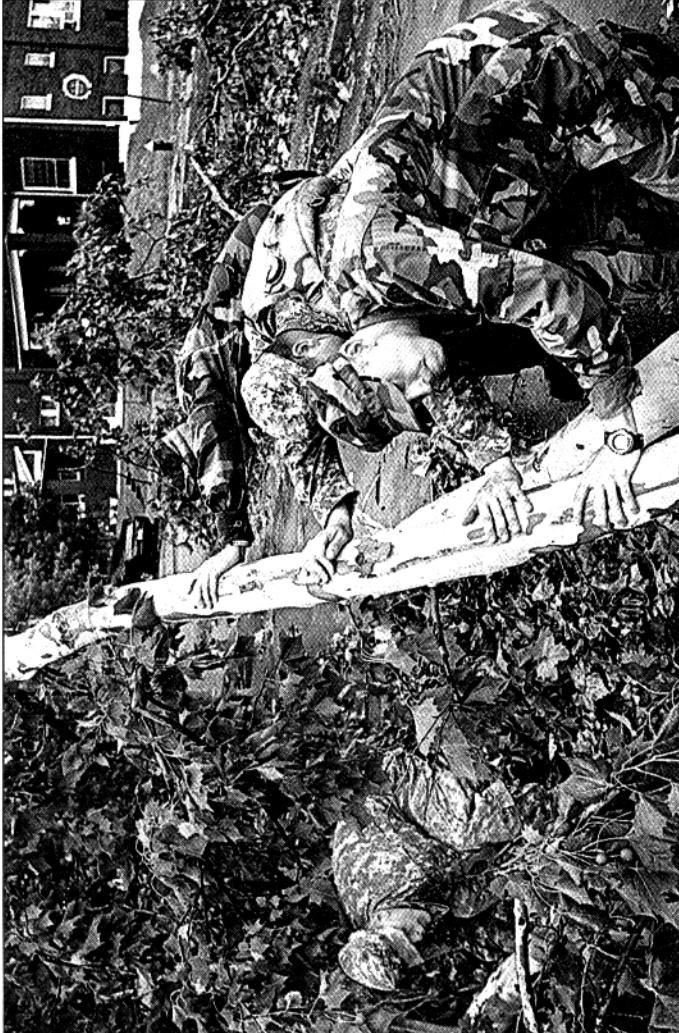
**Members of the Missouri National Guard removed a fallen limb off Kinghighway on Friday as they helped check on residents in the neighborhoods of north St. Louis, Missouri. Gov. Matt Blunt mobilized the troops to help the area recover from Wednesday's storms.**

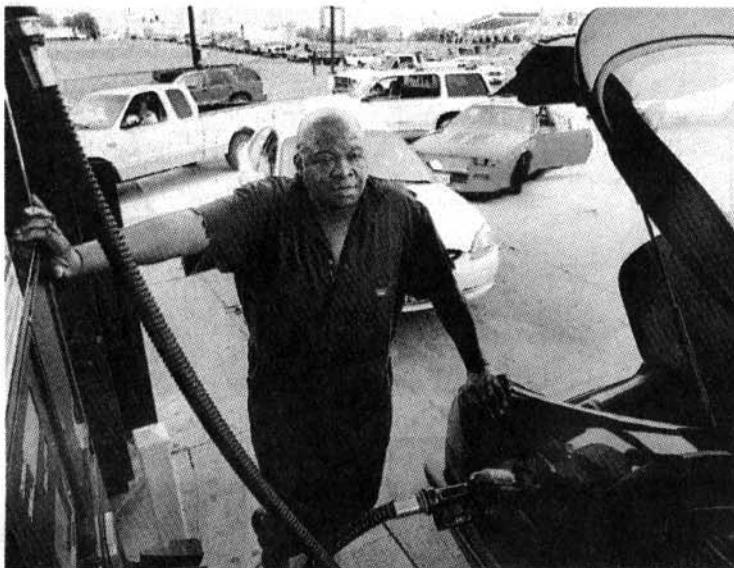
**Charley Williams fills his tank Friday at a QuickTrip in north St. Louis County. The station operated on a generator. Many stations that lost power were closed.** Jerry Naunheim Jr. | Post-Dispatch

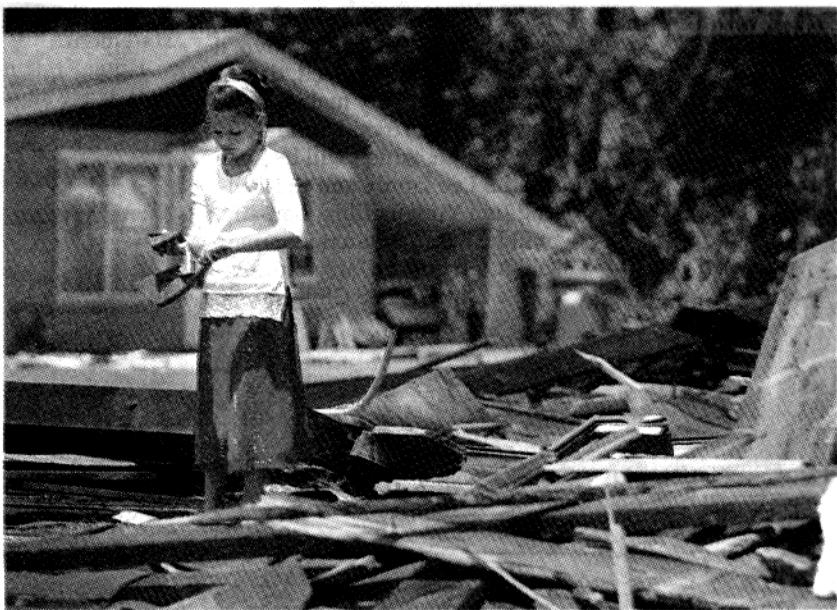
Allyson Heil, 9, of Hamel, stands Sunday amid the rubble of Landmark Pentecostal Church in Bethalto, which was shattered in Wednesday's storm. "I took a few mementos of our church," she said, with tears in her eyes. The congregation worshipped Sunday at First Baptist Church of Bethalto. Gabriel B. Tait | Post-Dispatch

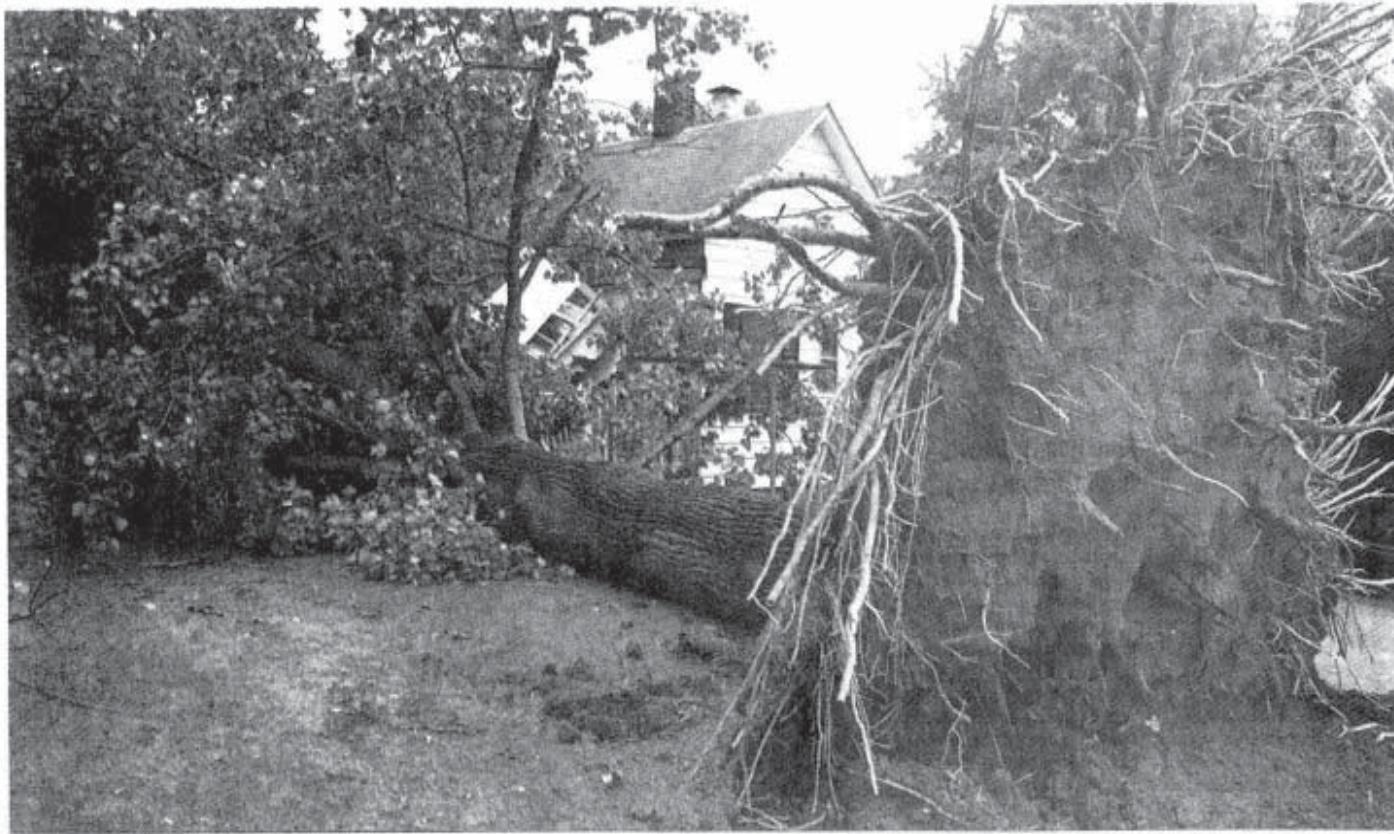
This tree fell on this home in Troy, Ill., during last week's storms. Claims for property damage from rain, wind, fallen trees and limbs, and lightning throughout the area have been filed with insurance companies. Dawn Majors | Post-Dispatch
